NPIC/R-1122/64

PHOTOGRAPHIC INTERPRETATION BRIEF

NAN-PING ARMY SUPPLY DEPOT SW, HSI-CHIN, CHINA

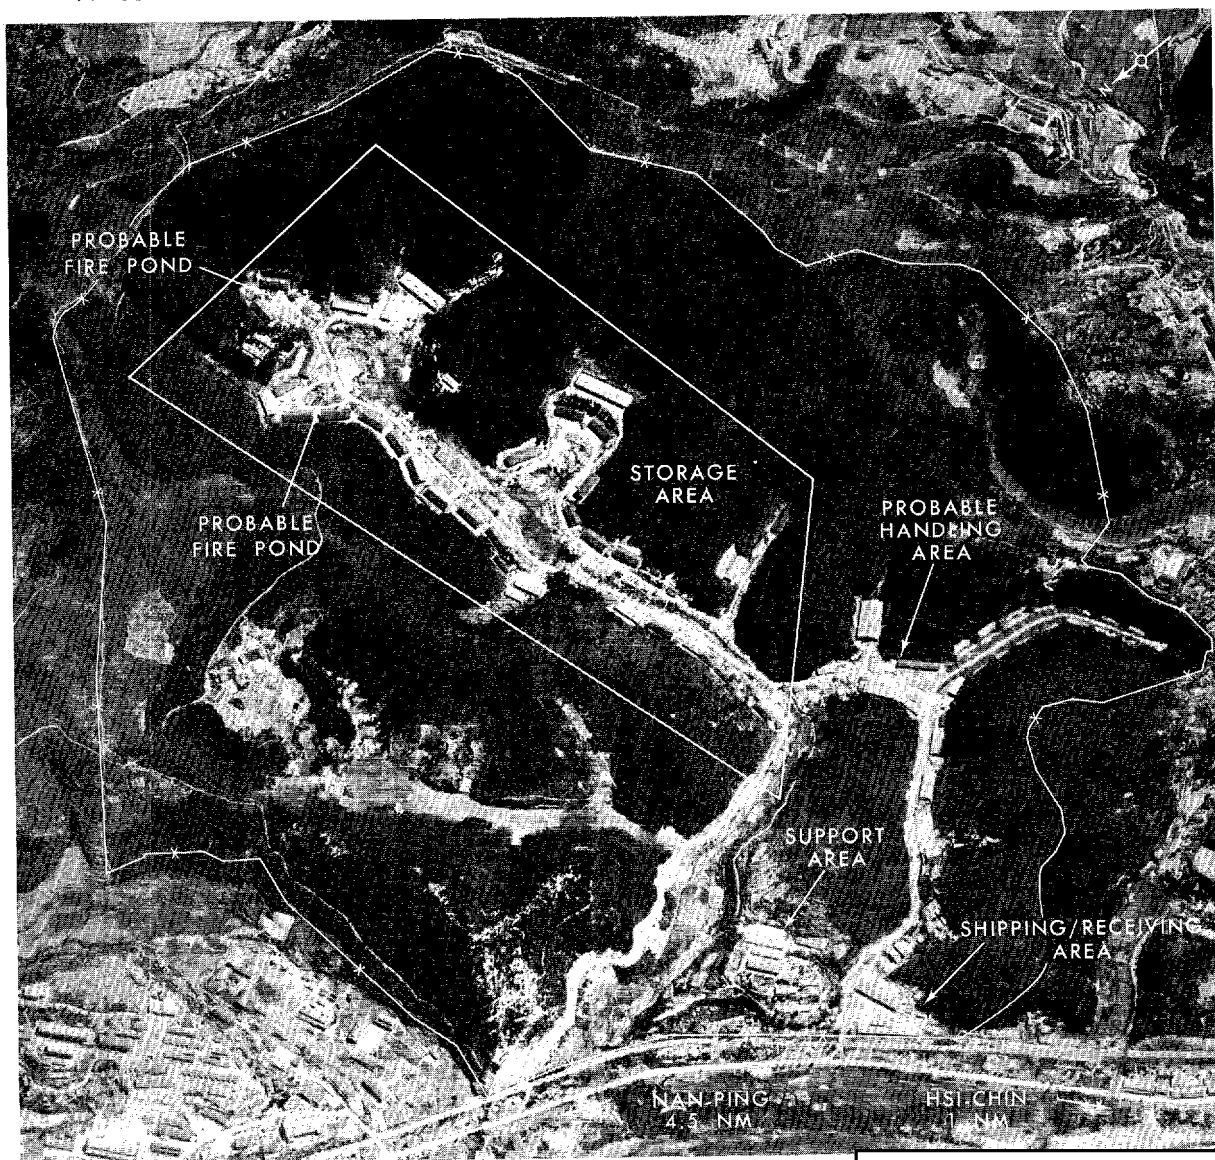
FIGURE 1. NAN-PING ARMY SUPPLY DEPOT SW, HSI-CHIN, CHINA,

A secured, road- and rail-served storage facility, approximately 280 acres in area, comprises 4 areas (storage, shipping/receiving, probable handling, and support), 4.5 nm SW of

Nan-ping and one nm NE of Hsi-chin (Figure 1).

The storage area contains 40 road-served storage buildings ranging from 80 x 25 ft to 200 x 55 ft, with a total floor space of approximately 165,000 sq ft. One building has a transverse monitor roof, and one a ventilated roof. Two probable fire ponds were observed in the SE section of the area.

The shipping/receiving area contains 2 large, rail-served warehouse-type buildings and 5 support buildings. Unidentified material in open storage was observed between the 2 large buildings on photography of [REDACTED]

The probable handling area contains 3 large buildings, 5 other associated buildings, and several stacks of unidentified material in open storage. Two buildings have been enlarged since the photography of [REDACTED] These

buildings are probably used in packaging and crating the material stored at this site. An apparently abandoned storage area with 14 cleared areas is located on a road immediately SW of the area.

The support area contains 4 probable barracks [REDACTED] 105 x 25 ft, and two 75 x 25 ft, with 12,150 sq ft total floor space), one large, dormer-roofed, probable administration building, and 4 support buildings. Based on 33.6 sq ft per man, the probable barracks can accommodate 360 personnel.
